HABITAT RESTORATION AGREEMENT BETWEEN THE MOUNTAINS
RESTORATION TRUST AND THE COUNTY OF LOS ANGELES TO FUND 2.2
ACRES OF OFF-SITE ENVIRONMENTAL MITIGATION AND PLANT 60 OAK TREES
FOR ROAD REPAIR PROJECTS
IN THE SANTA MONICA MOUNTAINS
(SUPERVISORIAL DISTRICT 3)
(3 VOTES)

Re-vegetation mitigation areas for County of Los Angeles Department of Public Works Road repairs sites that were damaged during the 2004-05 Winter Storm Events to compensate for permanent habitat losses

COUNTY OF LOS ANGELES DEPARTMENT OF PUBLIC WORKS MRT HABITAT RESTORATION

Grandview Drive 60 Feet North of Falls Drive Oak Tree Planting Project Proposal in Topanga State Park

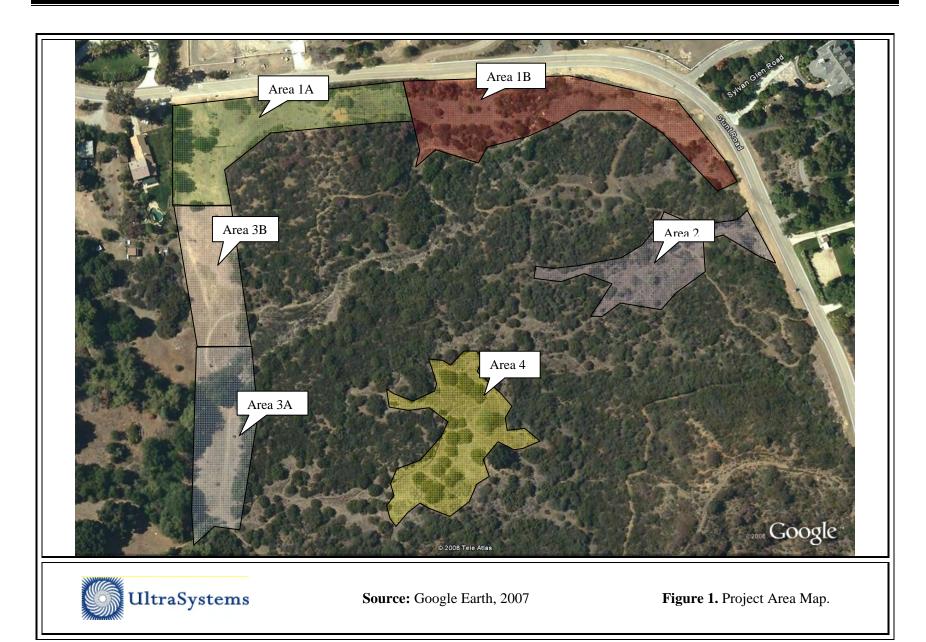
The six areas designated for restoration under this HMRP are outlined in *Figure 1. Table 1. MRT Site Acreages* displays the acreage to be restored for each Area as laid out in the Planting Plan. Restoration plans will be developed accordingly and include removal of non-native invasive species and installing native plants appropriate to the location, adjacent vegetation, soil type, water requirement, and number and type of native plants present. There is a total of approximately nineteen (19) acres available for restoration projects in the CCVP, of which three acres are planned for restoration under this HMRP.

Table 1. MRT Site Acreages				
Site #	Site Acreage	Restoration Acreage		
Area 1A & 1B	3.63	1.26		
Area 2	1.23	0.58		
Area 3A & 3B	1.88	1.03		
Area 4	4.32	0.82		
Total	11.06	3.69

The project site is located along Stunt Road, east of Mulholland Highway, and west of Sylvan Glen Road (*Figure 1. Project Area Map*). It is located within the U.S. Geological Survey (USGS) Malibu, CA, 7.5-minute series topographic quadrangle (Township 1S, Range 17W, Section 28). The proposed project includes the preparation and implementation of an HMRP for degraded areas located within the Cold Creek Valley Preserve (CCVP), owned by the MRT. There are eight specific locations within the CCVP characterized by disturbed areas dominated by non-native invasive species that are preventing the recurrence of native plant species, the basis of sustainable ecosystems. Of these eight, three areas have been identified for this HMRP. This HMRP will be used to conduct off-site mitigation work in order to satisfy the habitat restoration requirements of the CCC associated with conditions set forth in a permit for the repair of forty (40) LACDPW road sites that were damaged during the January/February 2005 storm events.

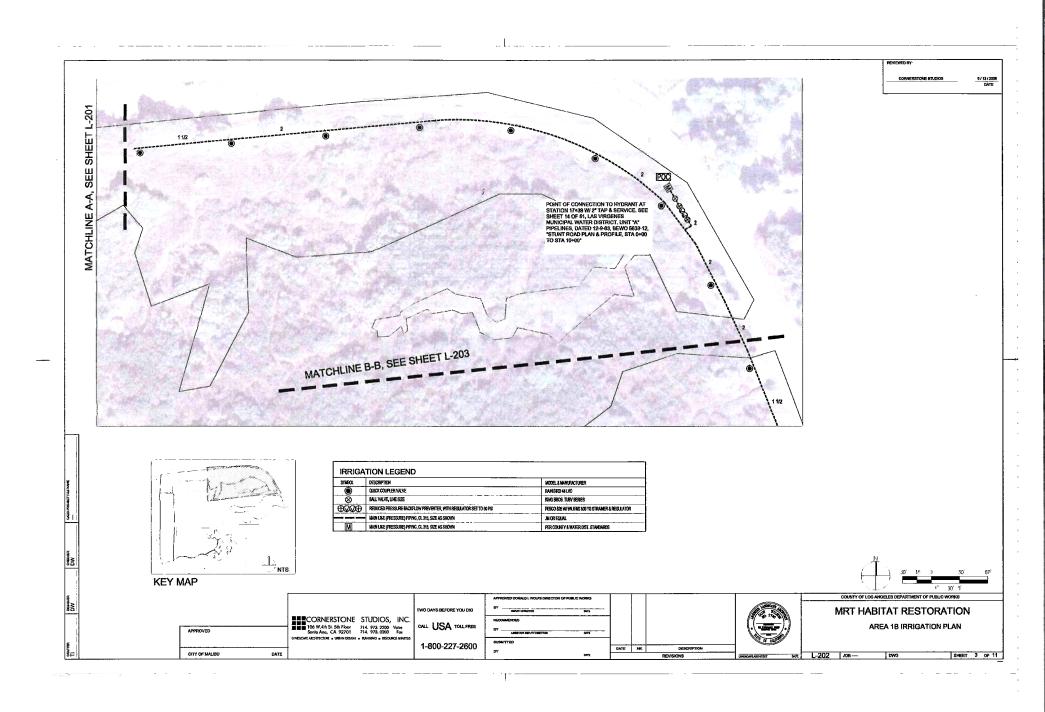
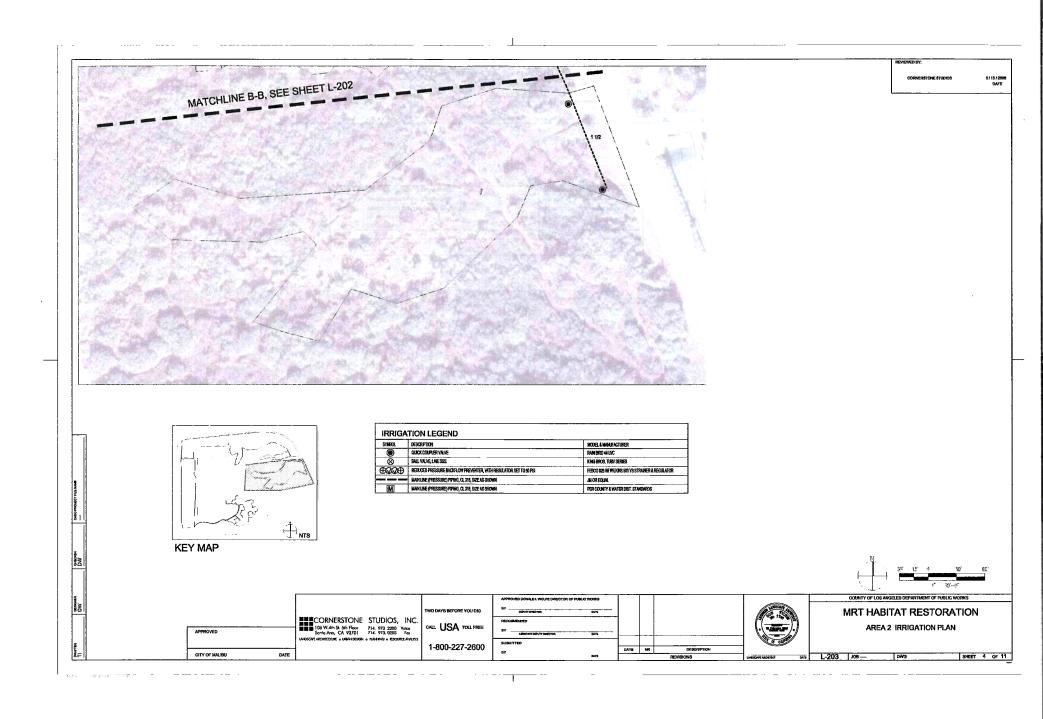
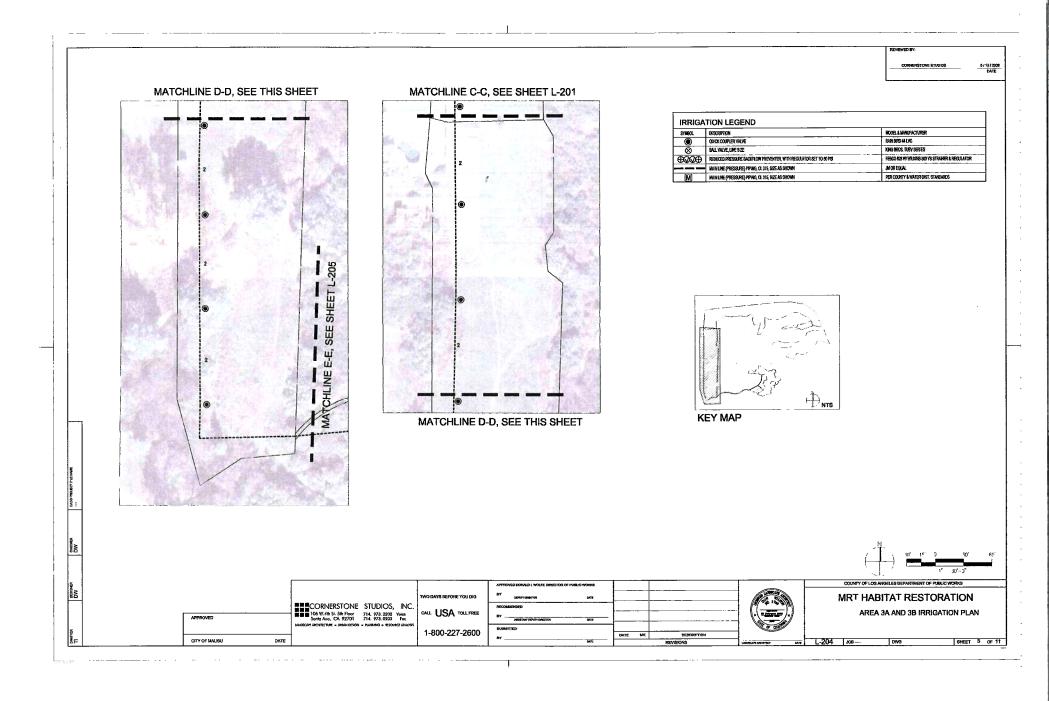
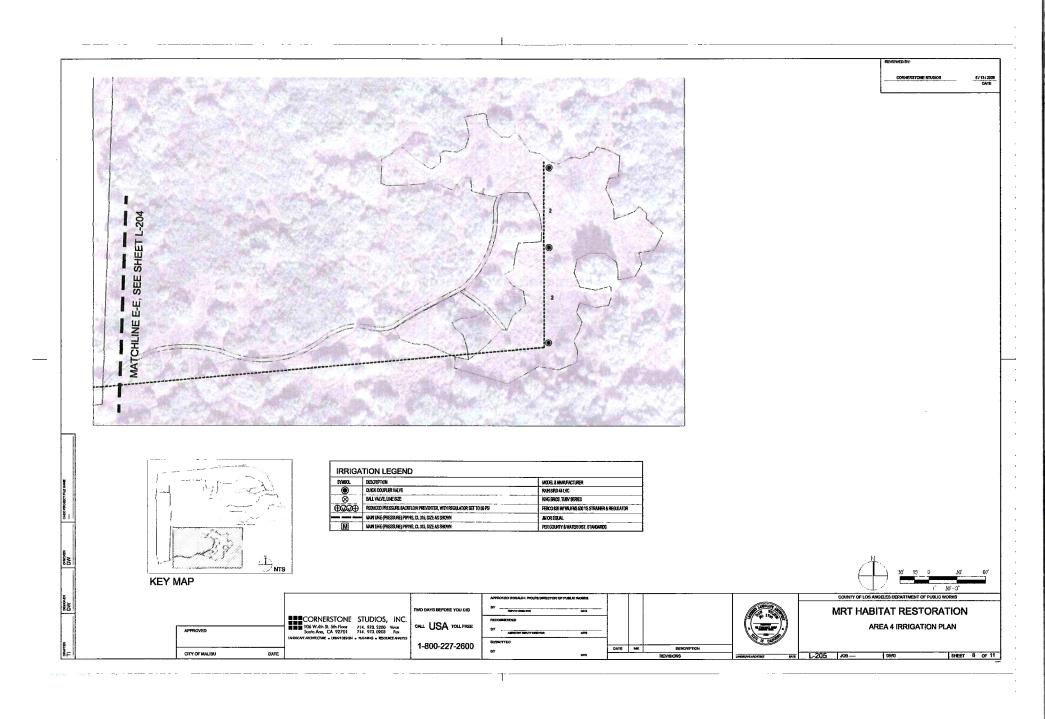
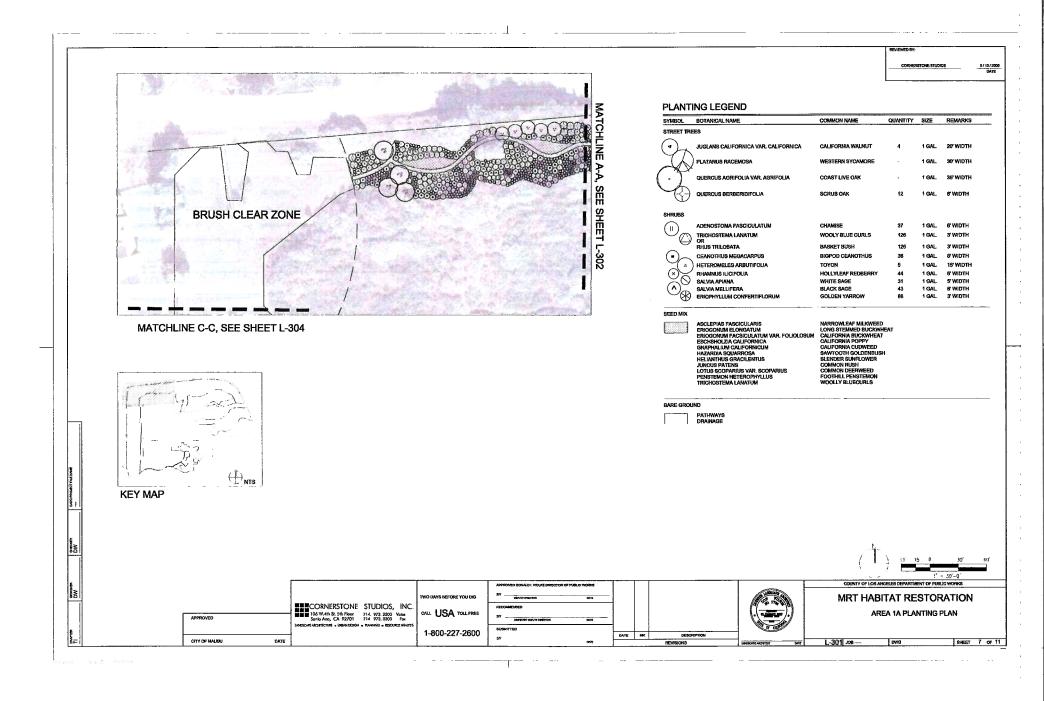
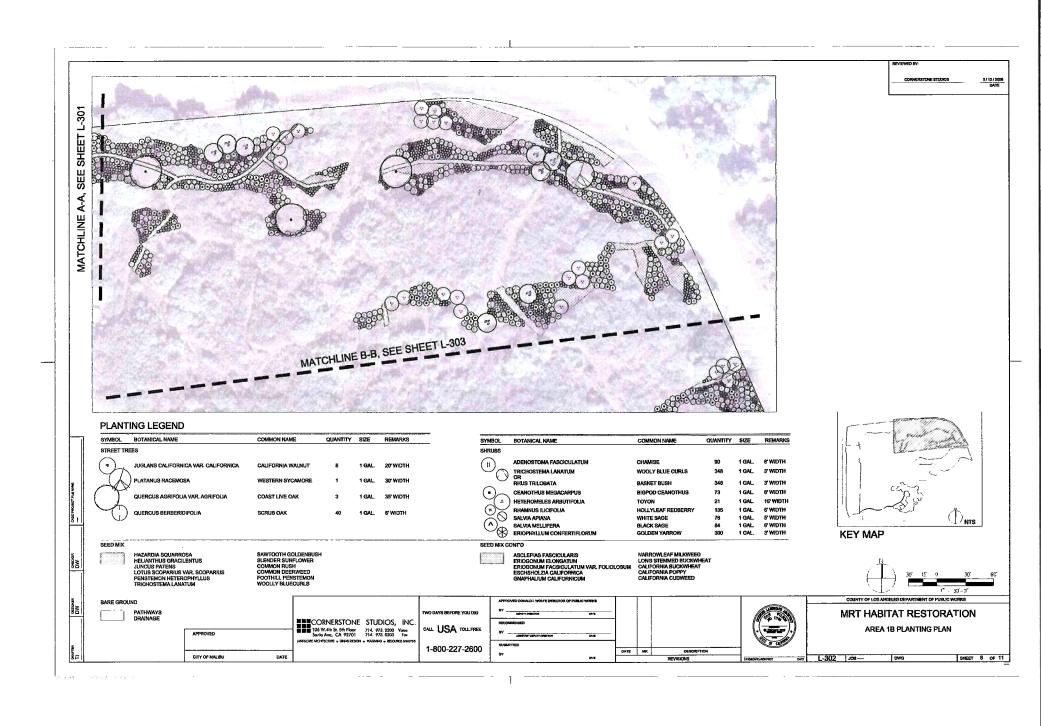
- 2 THE INSTALLATION OF THE IRRIGATION SYSTEM SHALL CONFORM TO ALL APPLICABLE REGULATIONS AND CODES.
- 3 THE IRRIGATION SYSTEM IS SHOWN DIAGRAMMATICALLY FOR CLARITY. LOCATE ALL PIPMS, EQUIPMENT AND APPURTENANCES WITHIN THE PLANTING AREAS SHOWN LUISES NOTED OR RECRETED THERIWISE. LOCATE ALL VALVES AND VALVE BOXES & MIN., 12° MAY FROM PAVING. LOCATE GUICK COUPLER VALVES AT THE EDGE OF PLANTING AREAS. LOCATE PRESSURE MAIN LINES WITHIN 12° OF EDGE OF FLANTING AREAS.

Prior to planting, a series of temporary irrigation lines will be installed as laid out in the Planting Plan. Immediately after planting, water will be applied to each shrub. Water should be applied in a moderate stream into the planting hole until the material around the roots is completely saturated from the bottom of the hole to the top of the ground. Water should be applied in sufficient quantities and as often as seasonal conditions require to keep planted areas moist, well below the root system of the plants.
